Subject: EPA Inspection Report

**CWA COMPLIANCE EVALUATION INSPECTION REPORT
U.S. ENVIRONMENTAL PROTECTION AGENCY, REGION 5**

Compliance Evaluation Sampling Inspection

FOIA Ex. 6
(Personal) Farms, LLC
FOIA Ex. 6 (Personal Privacy)

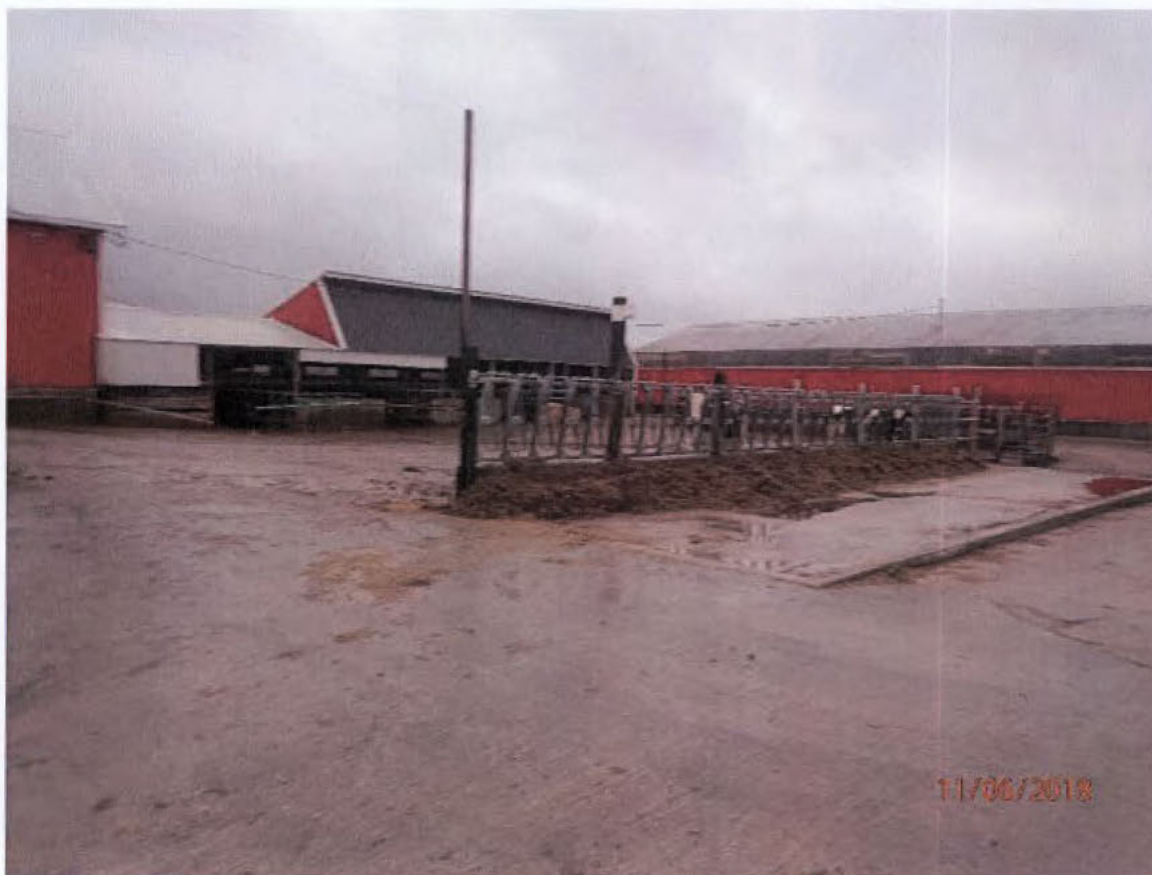
36: PB060038

EPA then walked to the east to the open pens for the Heifer Barn and Steer Barn. The pens had concrete floors and the slope of the concrete allowed the manure and process wastewater to flow to the east toward a solid stacking bunker. At the base of the east wall of the solid stacking bunker there were three holes approximately one foot above the base and an additional three weep holes below those – at ground level. EPA observed manure and process wastewater flowing to the east from the open pen and out the middle hole at ground level.

Description: There is no containment for manure and process wastewater from open concrete lots to the north of the Heifer Barn.

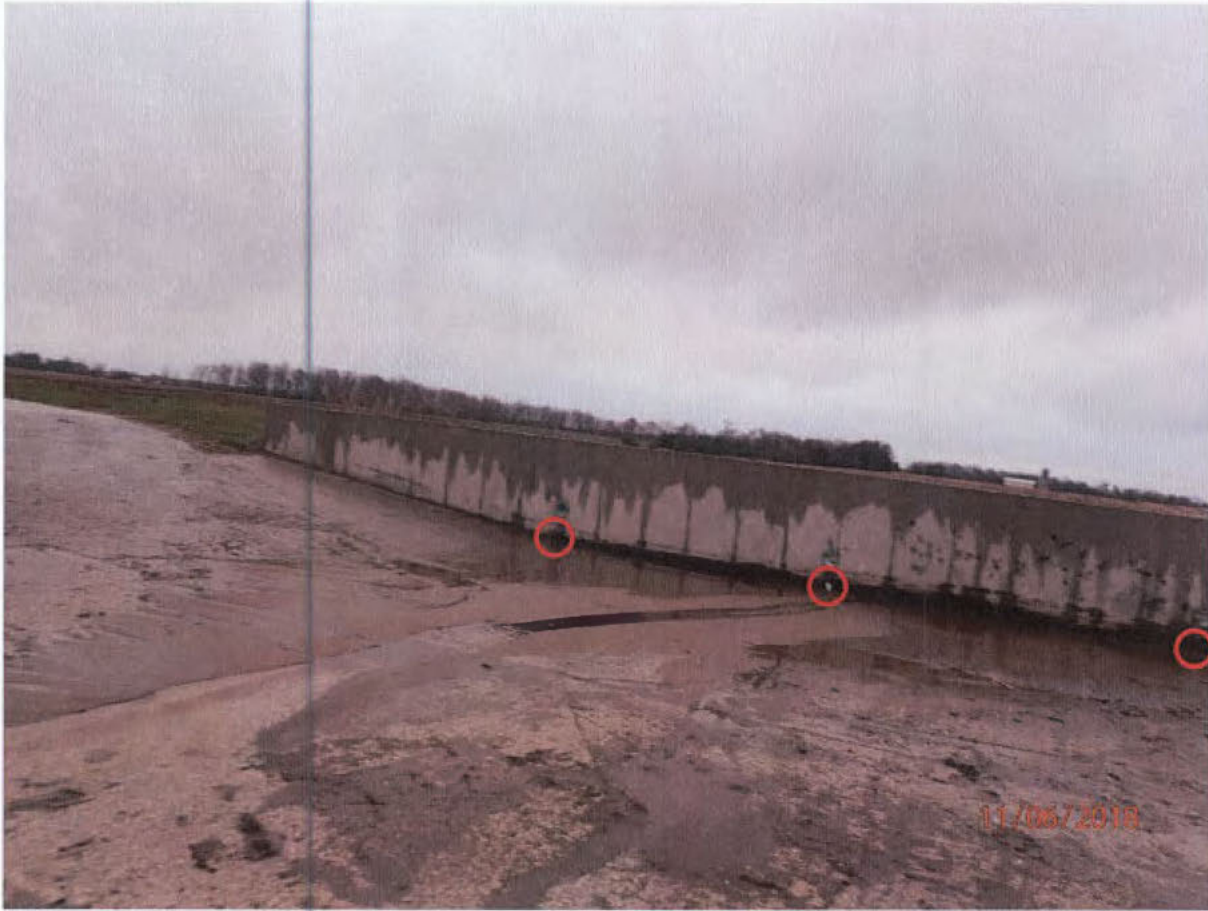
37: PB060039

Description: Concrete wall on east side of open heifer pens has three weep holes at the bottom where manure and process wastewater can discharge to the east. Weep holes at the base of the concrete (red circles) are directly below the holes in the concrete with green/blue pipe inside. The weep hole to the far right in the photo is plugged with manure.

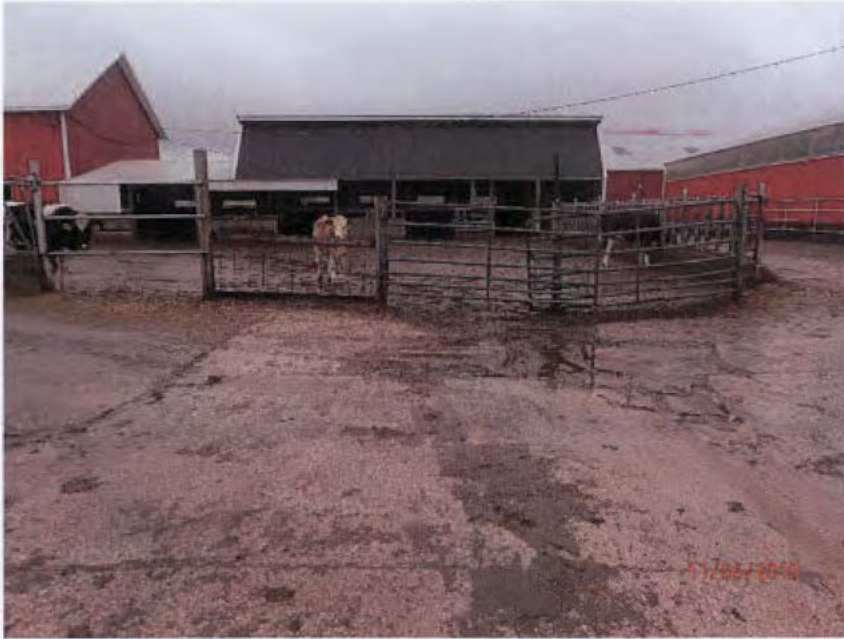
38: PB060040

Description: Discharge of manure and process wastewater from the open pen flows directly to the center weep hole in the concrete wall.

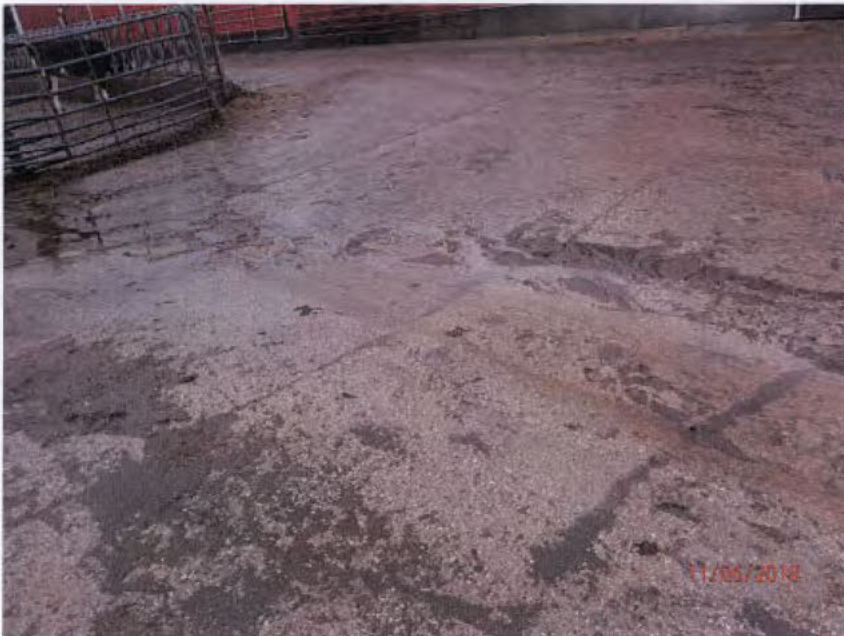
39: PB060041

Description: Discharge pathway from open pen flows to center weep hole in concrete wall.

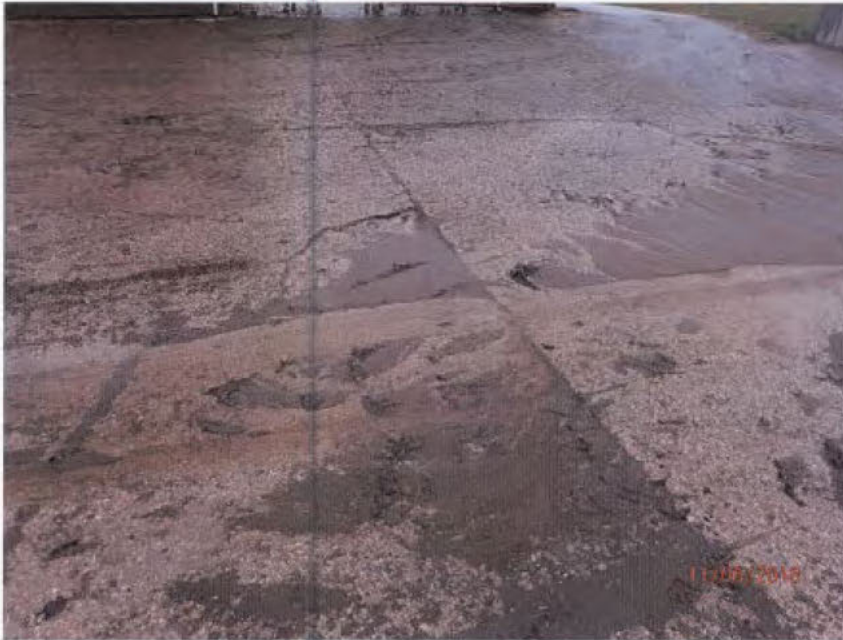
40: PB060042

Description: Discharge pathway from open pen flows to center weep hole in concrete wall.

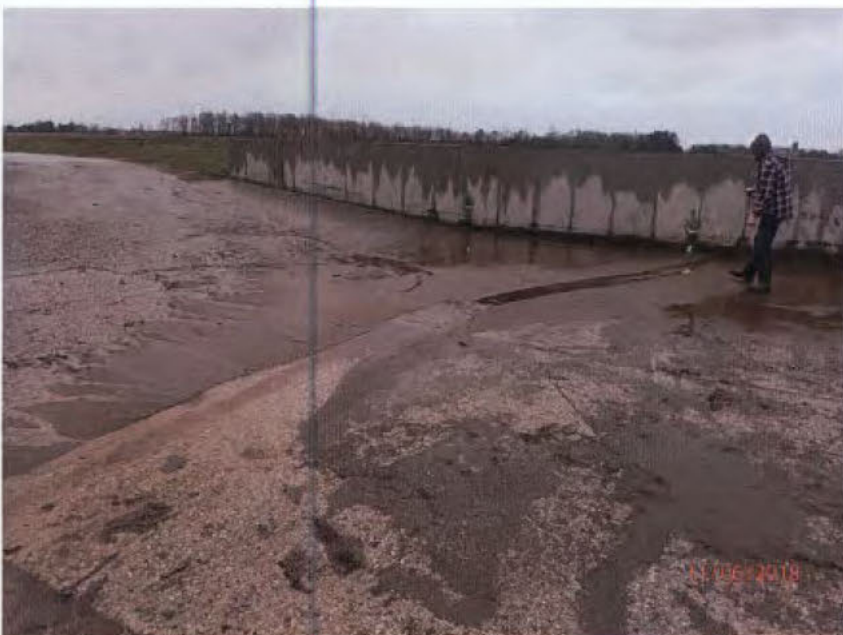
41: PB060043

Description: Discharge pathway from open pen flows to center weep hole in concrete wall.

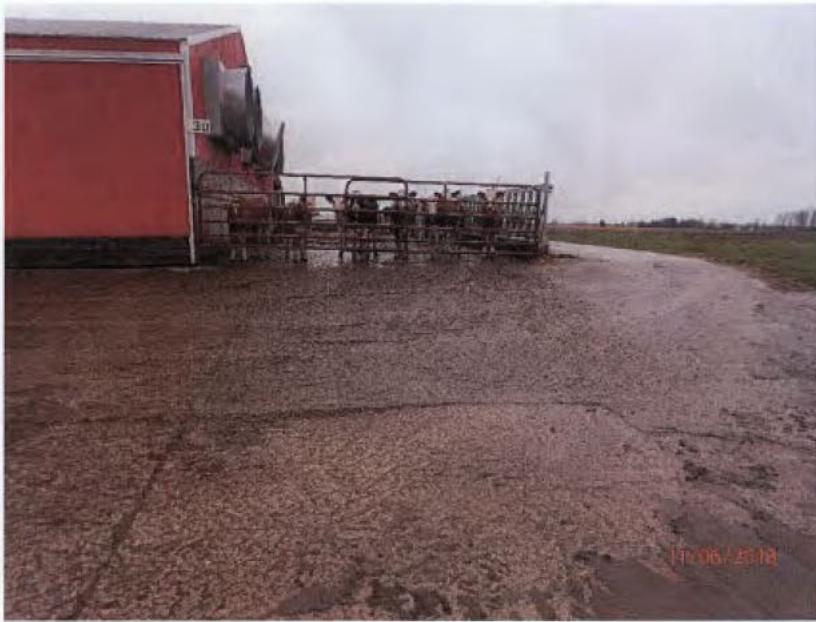
42: PB060044

Description: There is no containment for manure and process wastewater from another open pen on the east side of Barn #30, the Heifer Barn. Manure and process wastewater would flow to the south and to a weep hole in the concrete wall.

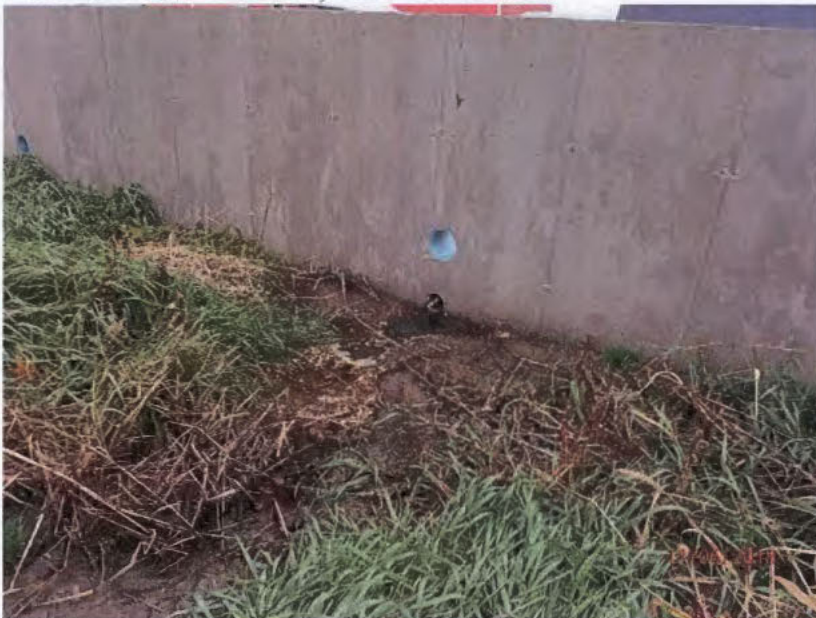
43: PB060045

Description: The manure and process wastewater exits the weep hole on the east side of the concrete wall.

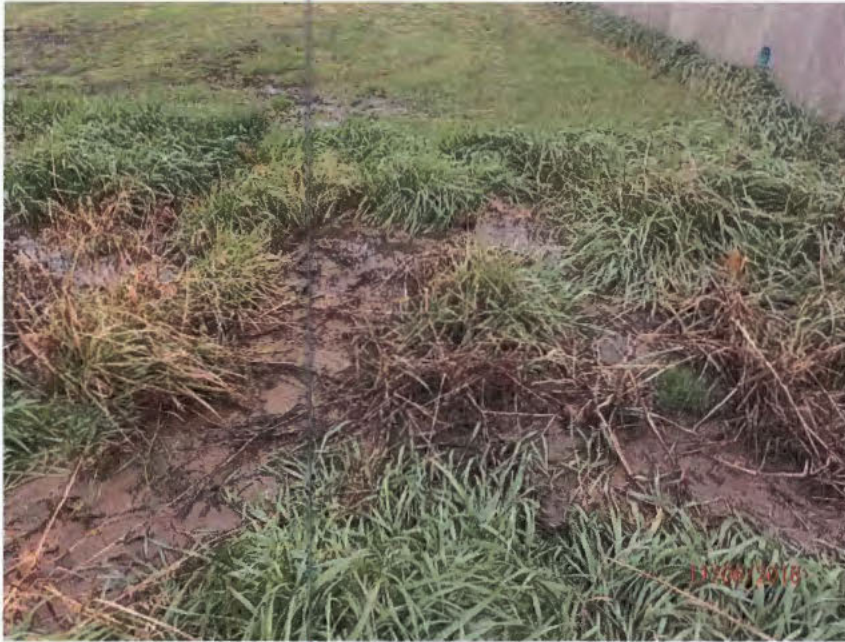
44: PB060046

EPA walked to the east side of the bunker wall and then walked and documented the pathway of manure and process wastewater all the way to the intermittent unnamed tributary. The flow in the pathway was continuous and EPA documented this with photos and a video (PB060078.MOV) of the liquid from the pathway as it flowed into the intermittent unnamed tributary.

Description: The discharge pathway from the weep hole in the concrete wall had flow in it the whole way to the intermittent unnamed tributary.

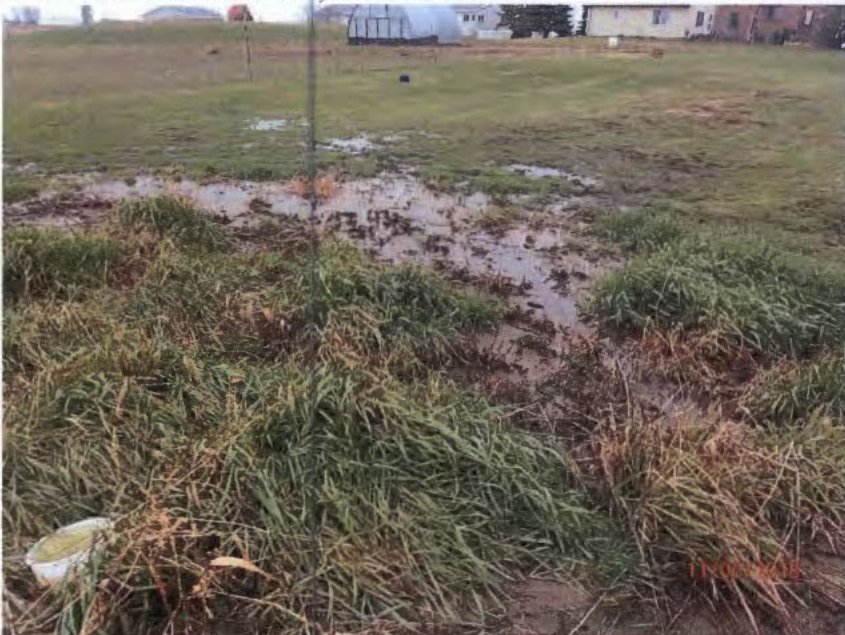
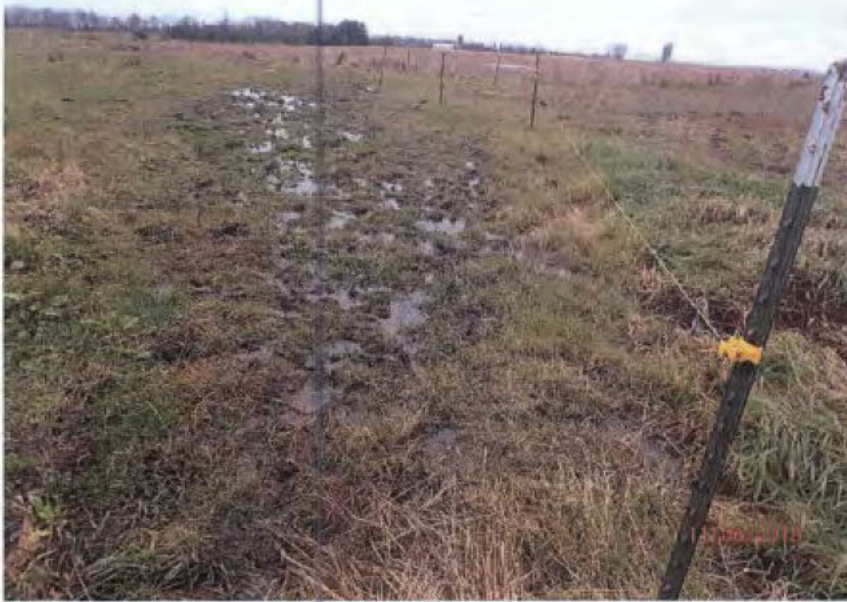
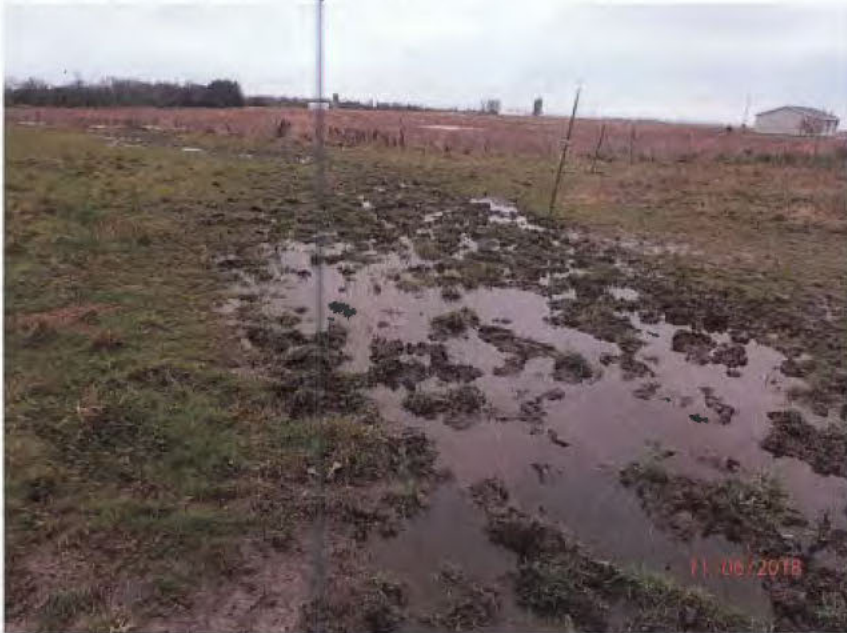
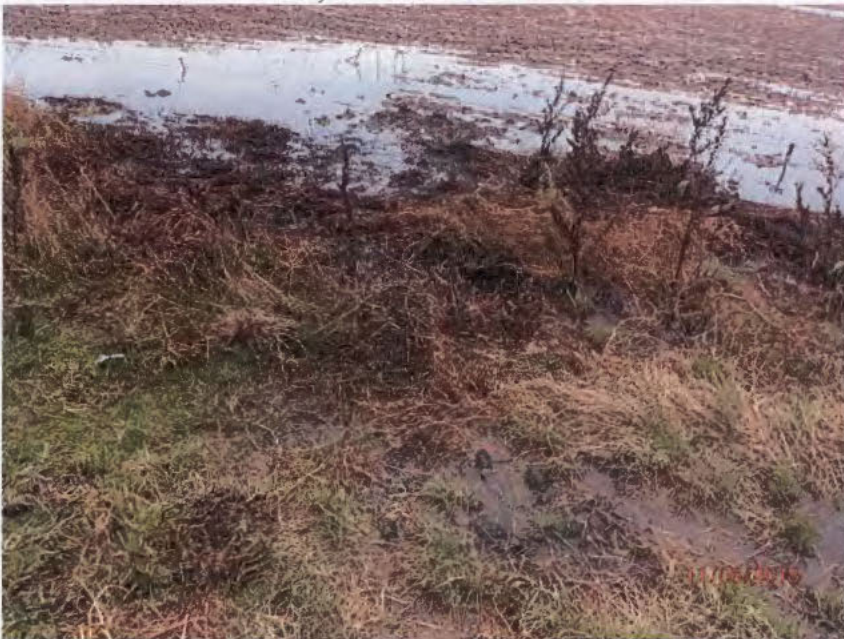
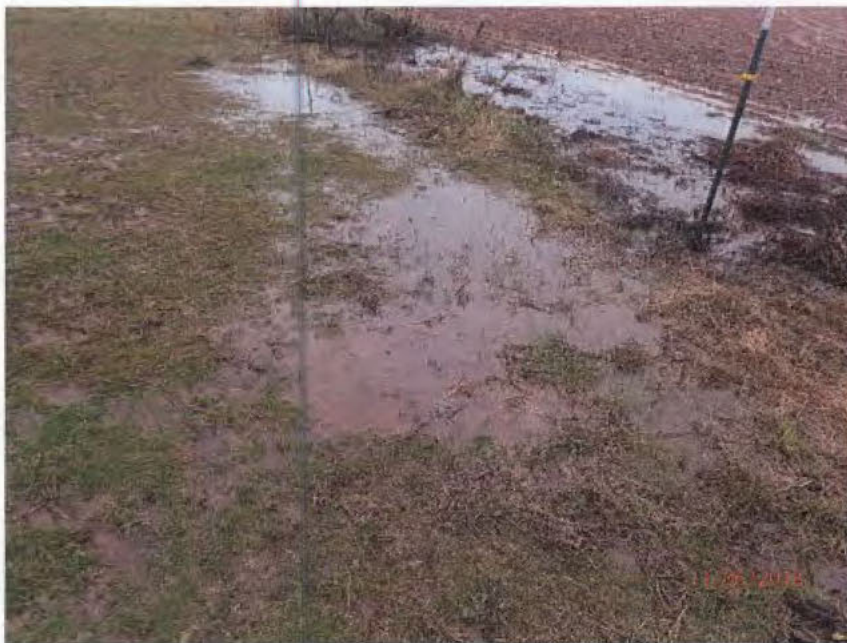
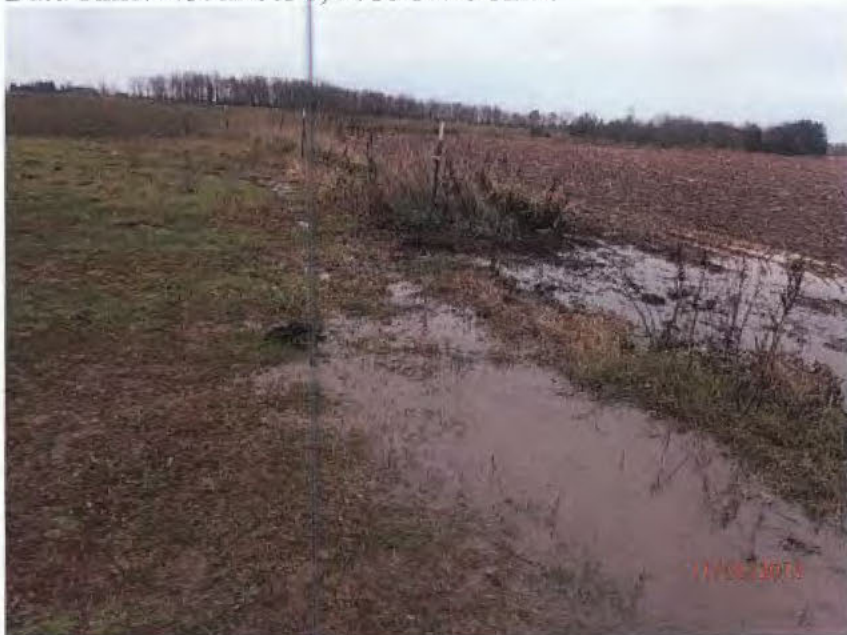
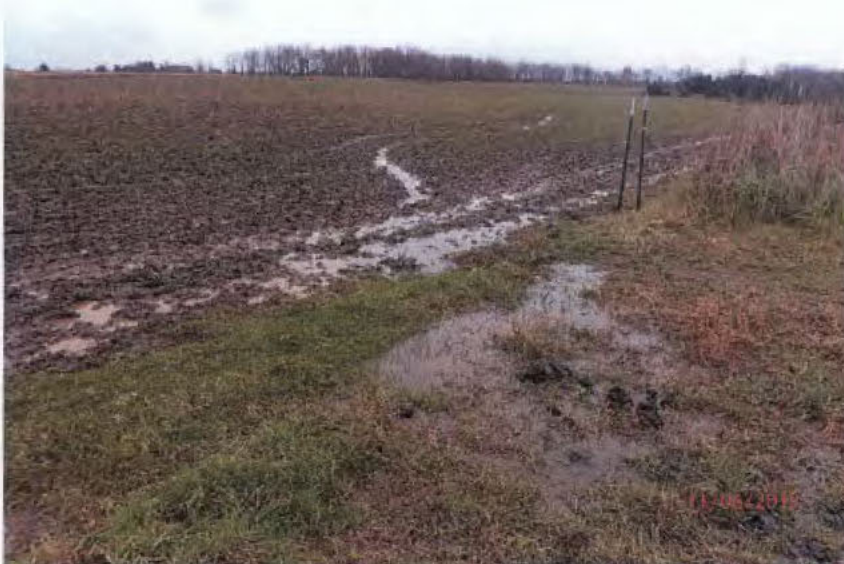
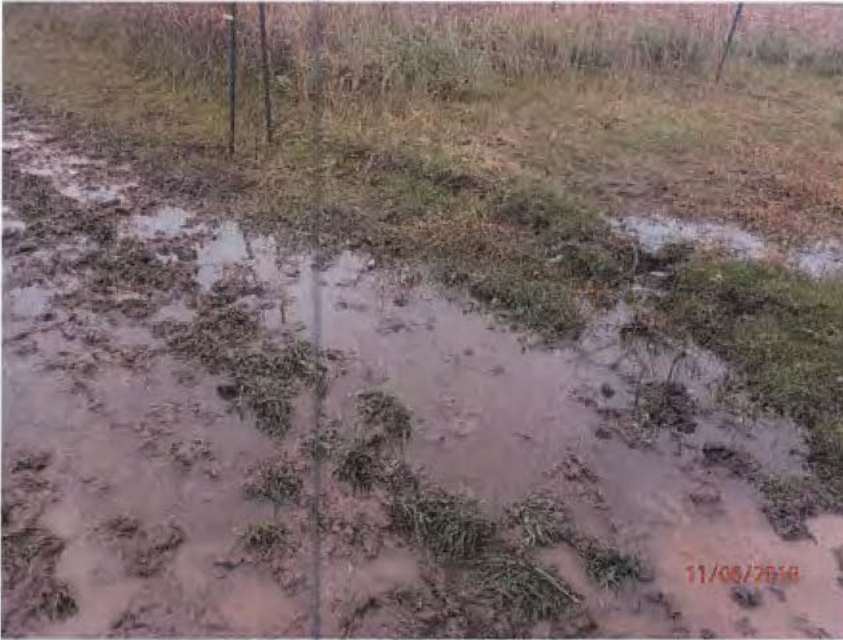
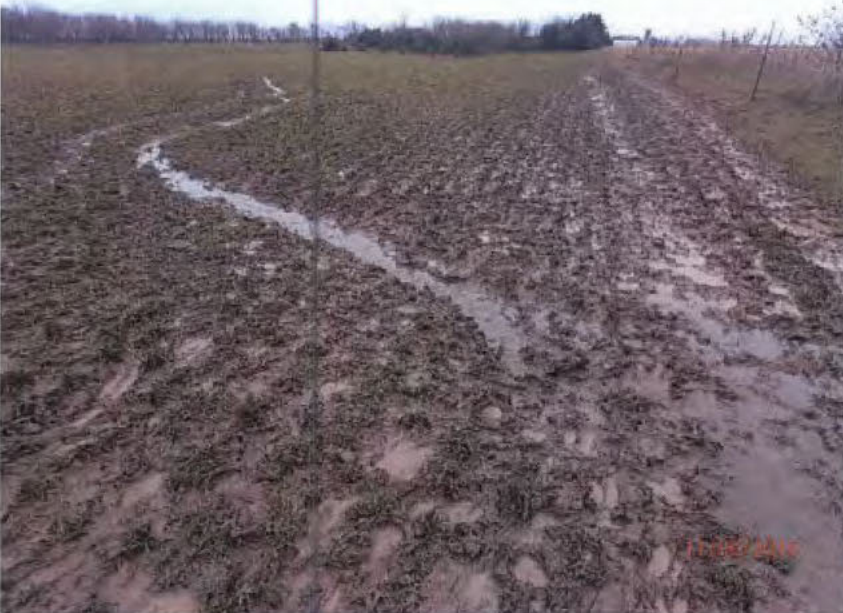
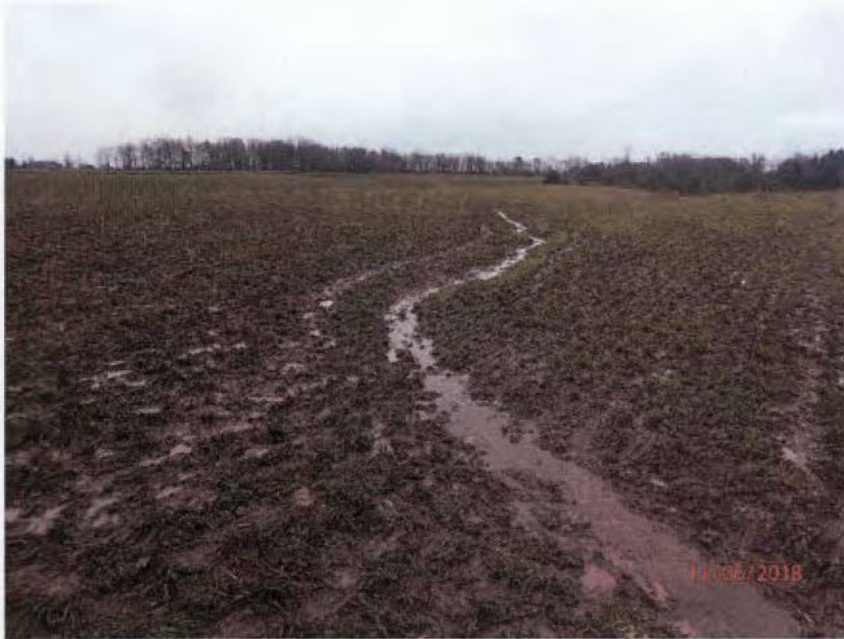
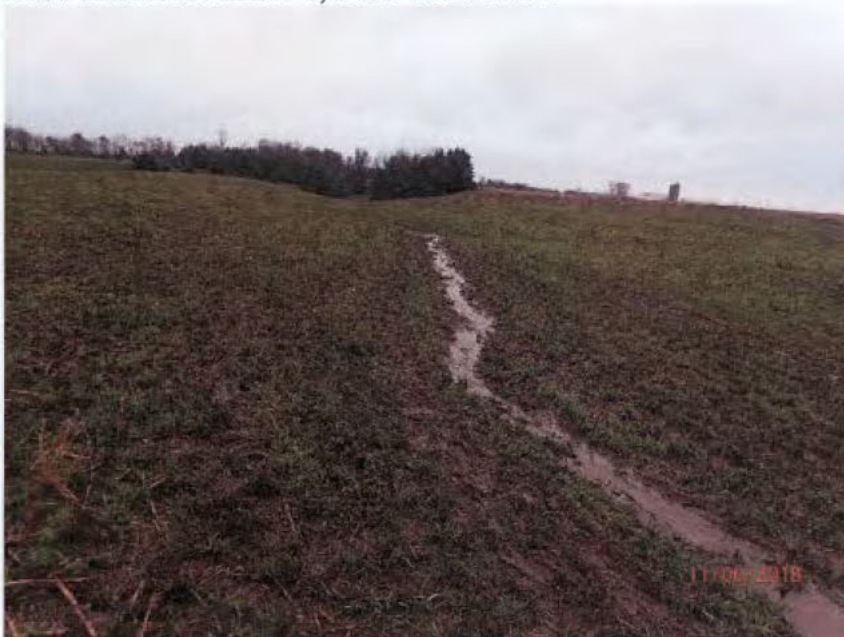
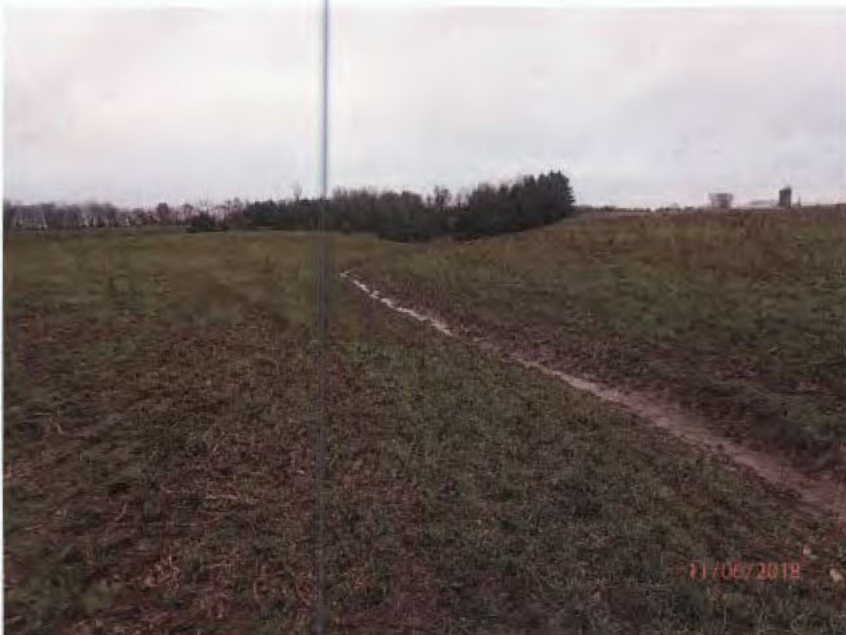
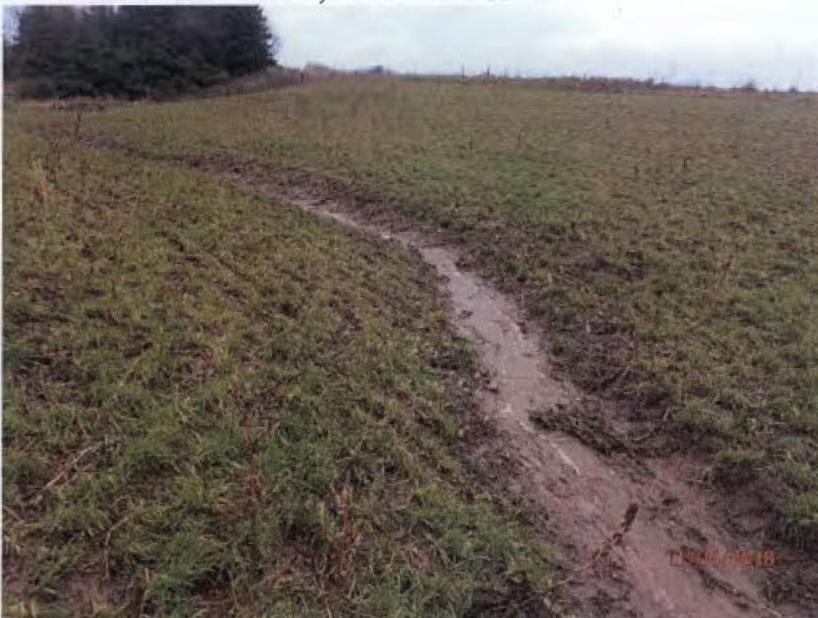
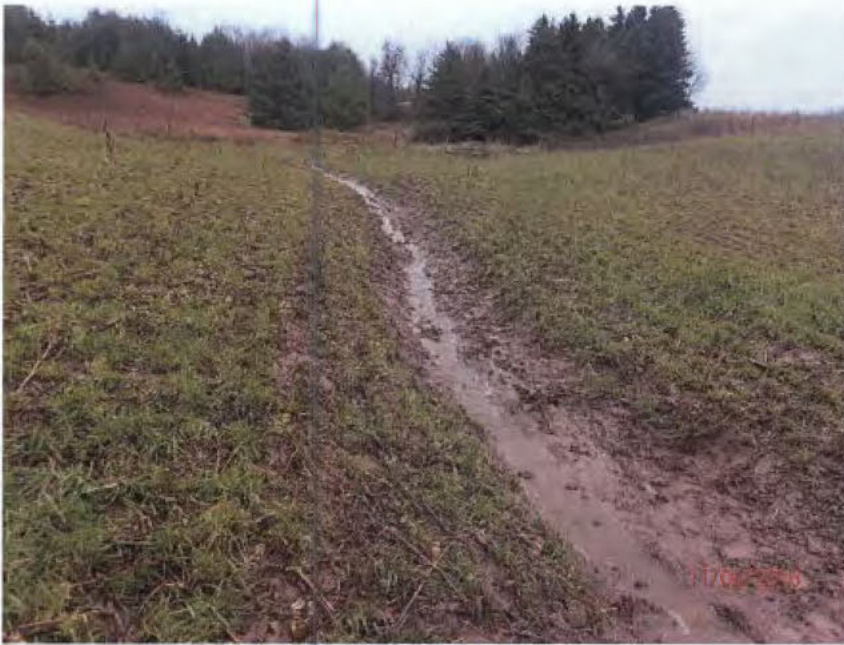
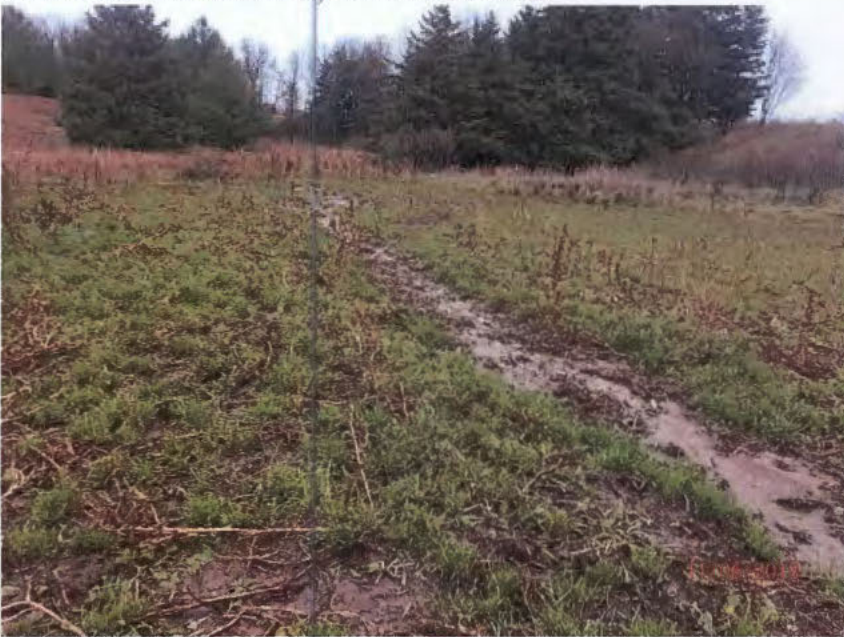
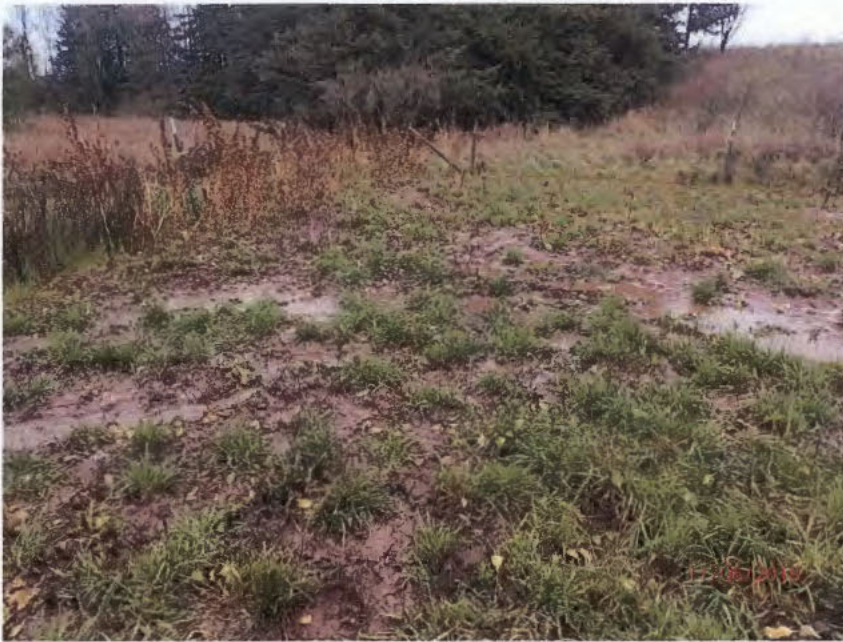
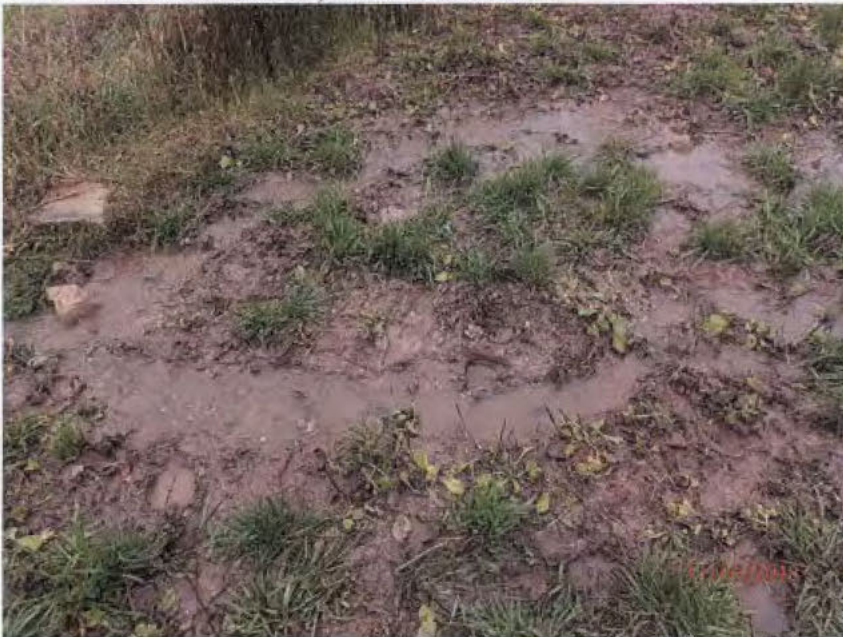
Description: EPA documented flow in the discharge pathway from the weep hole in the concrete wall all the way to the intermittent unnamed tributary.

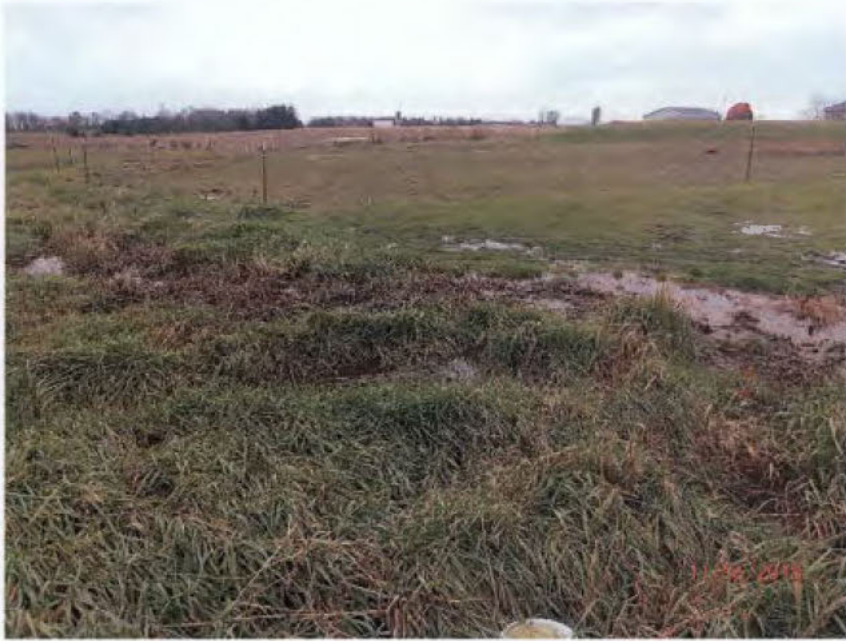
46: PB060048

Description: EPA documented flow in the discharge pathway from the weep hole in the concrete wall all the way to the intermittent unnamed tributary.

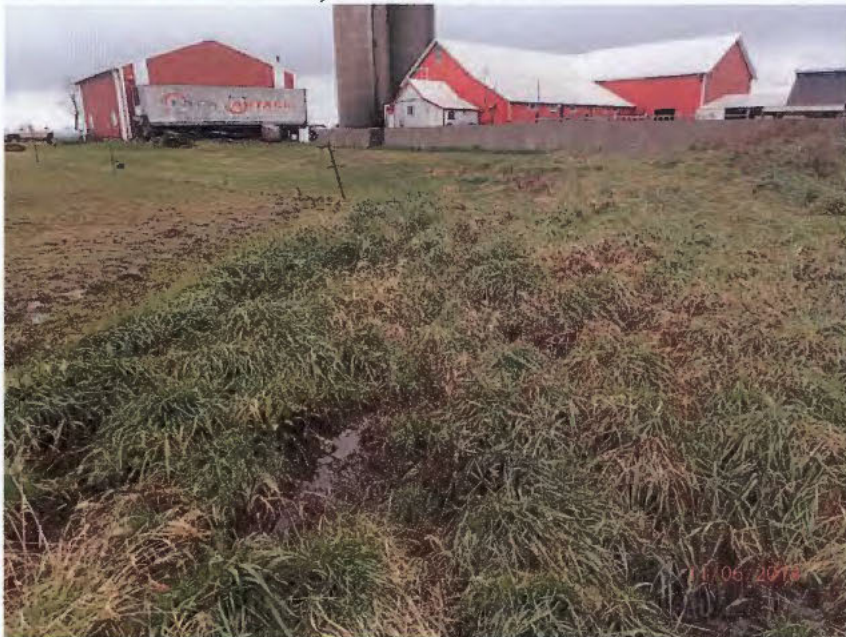
47: PB060049

Description: EPA documented flow in the discharge pathway from the weep hole in the concrete wall all the way to the intermittent unnamed tributary.

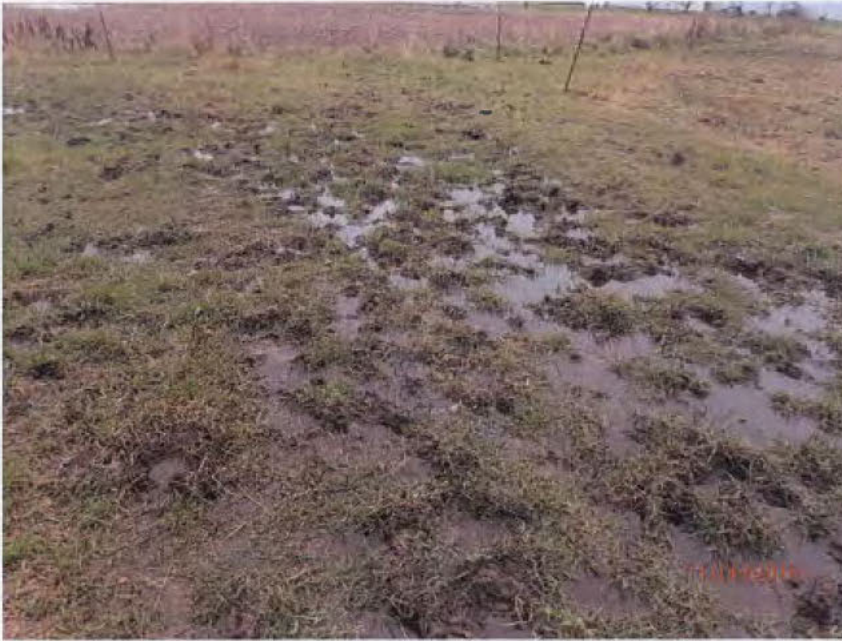
50: PB060052

Description: EPA documented flow in the discharge pathway from the weep hole in the concrete wall all the way to the intermittent unnamed tributary.

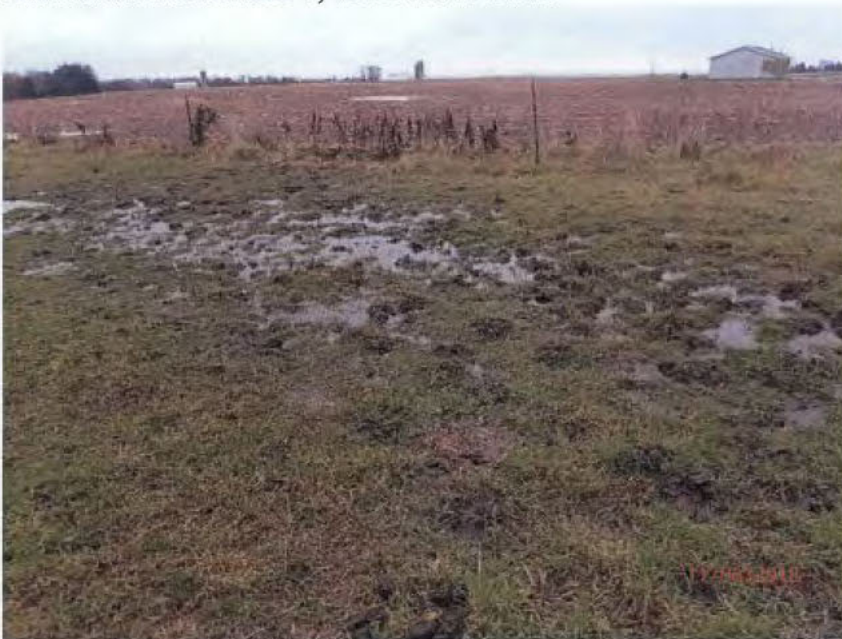
51: PB060053

Description: EPA documented flow in the discharge pathway from the weep hole in the concrete wall all the way to the intermittent unnamed tributary.

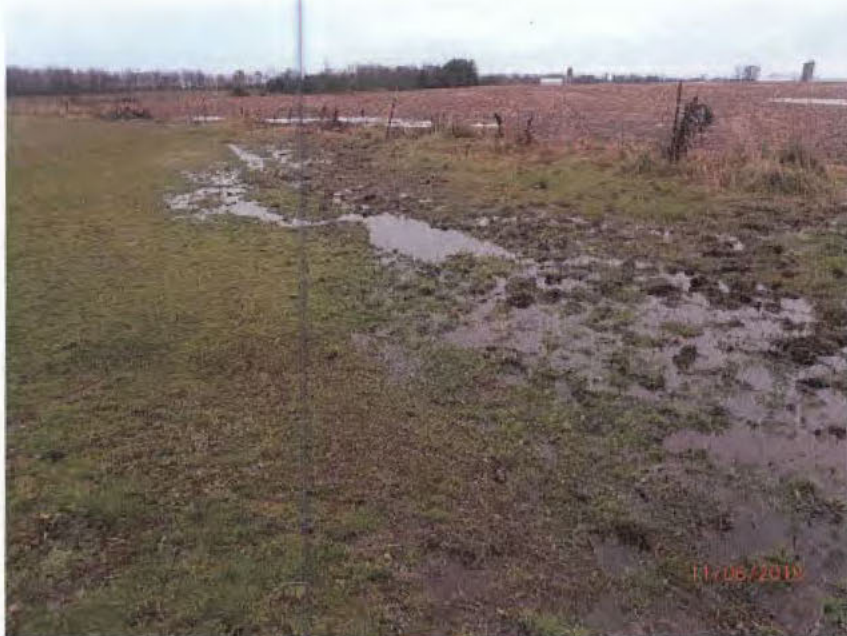
52: PB060054

Description: EPA documented flow in the discharge pathway from the weep hole in the concrete wall all the way to the intermittent unnamed tributary.

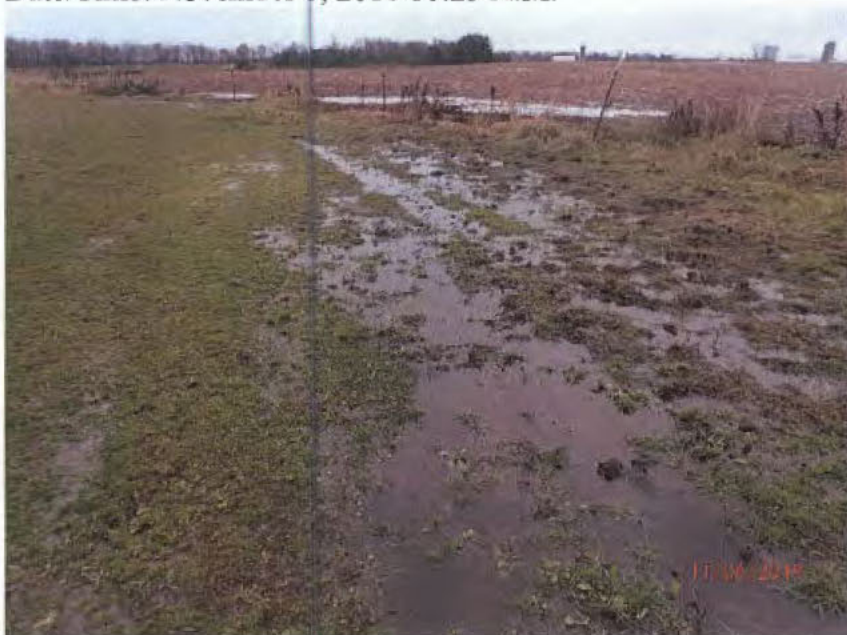
53: PB060055

Description: EPA documented flow in the discharge pathway from the weep hole in the concrete wall all the way to the intermittent unnamed tributary.

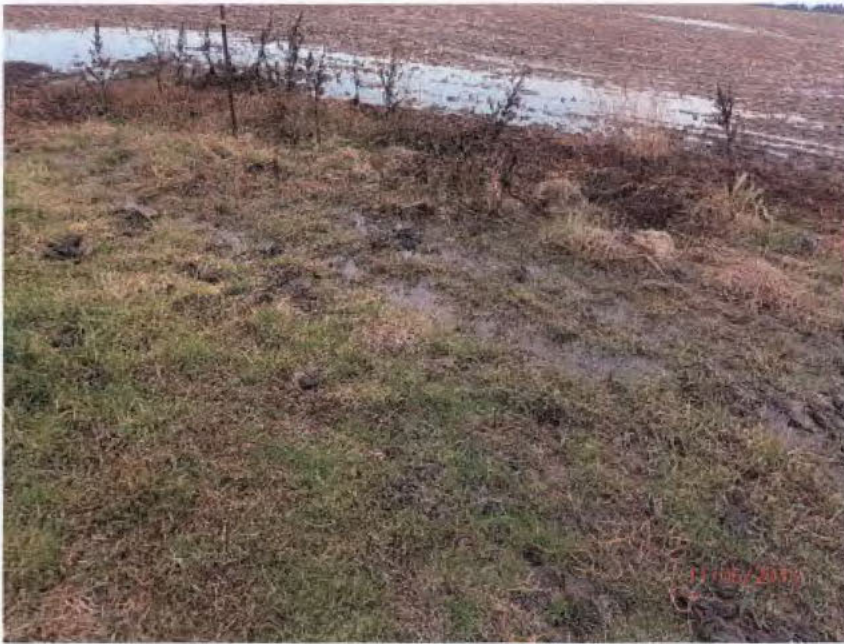
54: PB060056

Description: EPA documented flow in the discharge pathway from the weep hole in the concrete wall all the way to the intermittent unnamed tributary.

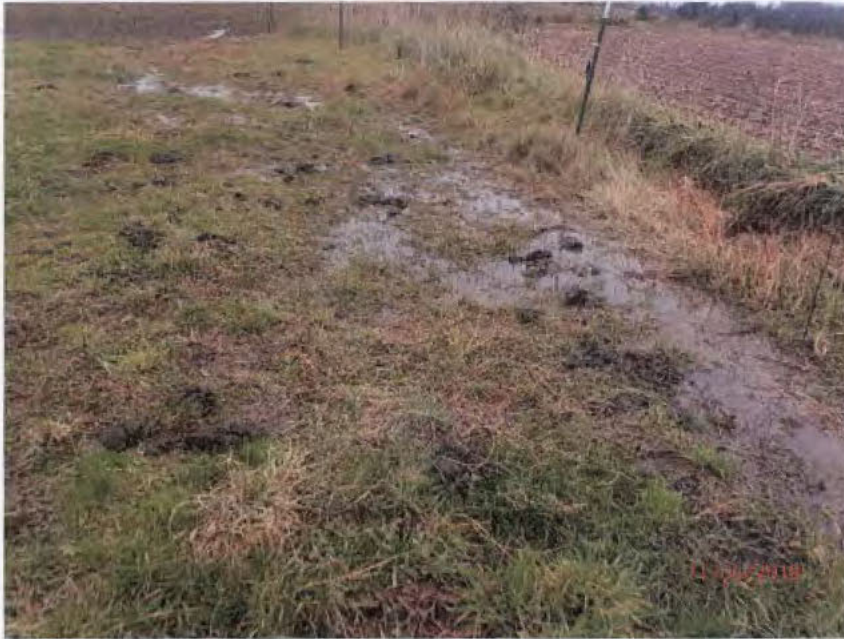
58: PB060060

Description: EPA documented flow in the discharge pathway from the weep hole in the concrete wall all the way to the intermittent unnamed tributary. Note the piles of manure in the pathway.

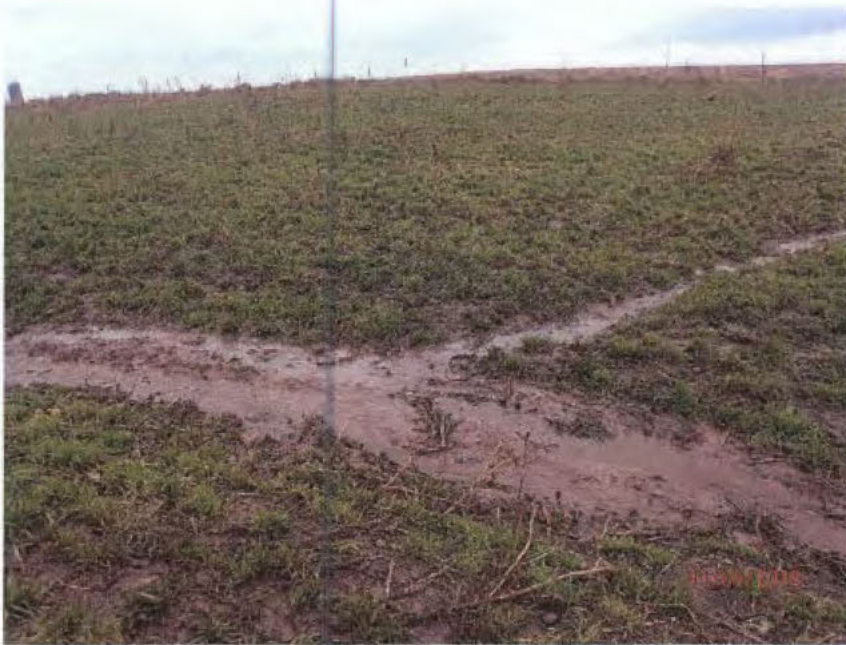
64: PB060066

Description: Flow from the agricultural field to the south joins the discharge pathway.

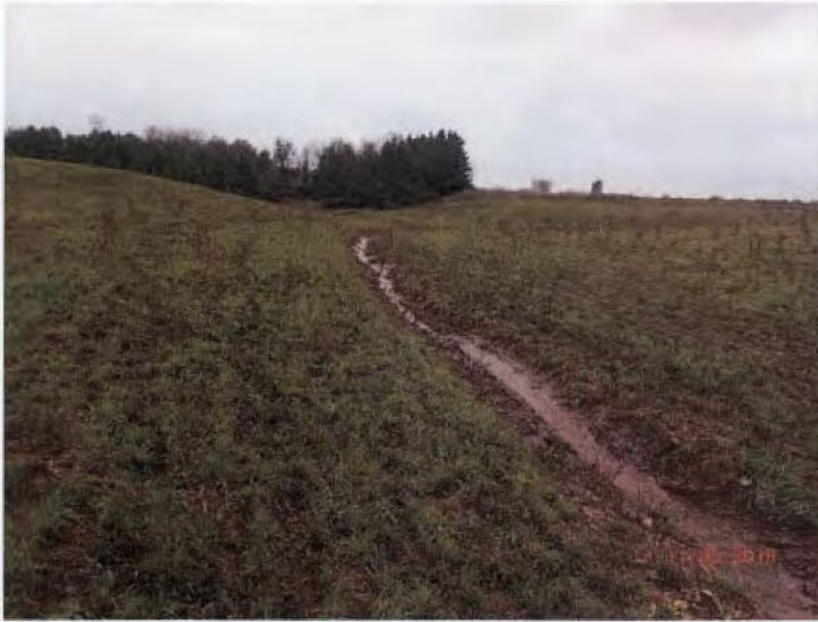
66: PB060068

Description: EPA documented flow in the discharge pathway from the weep hole in the concrete wall all the way to the intermittent unnamed tributary. The pathway began having a bed and bank.

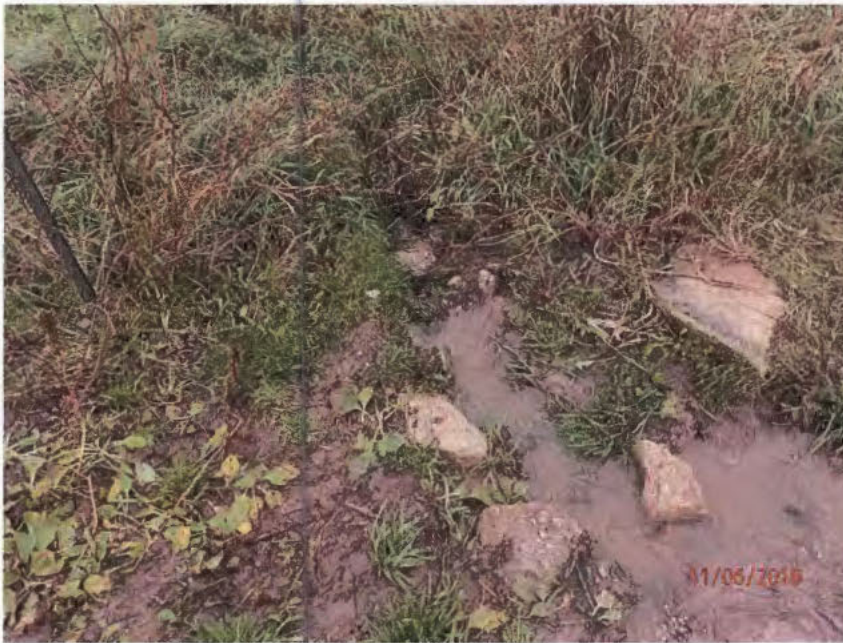
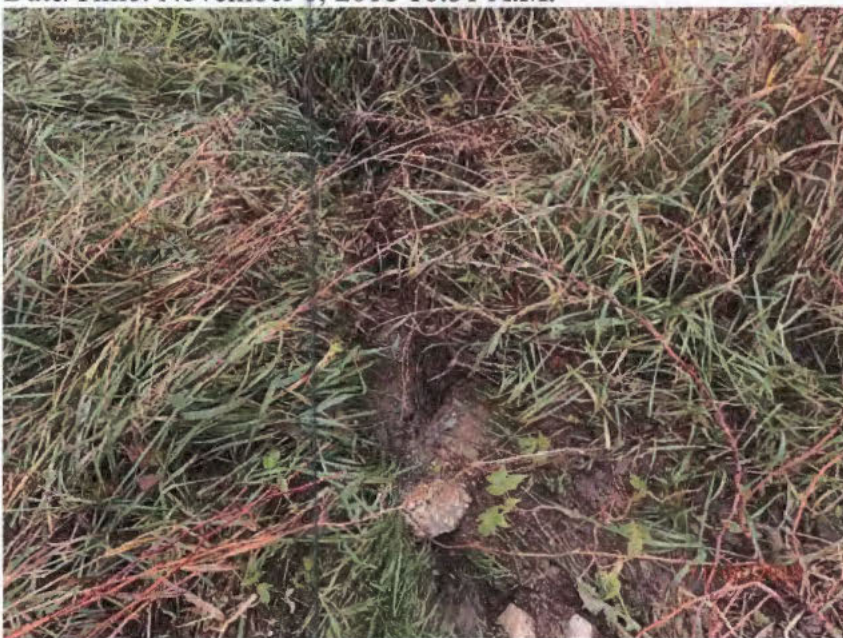
Description: Discharge pathway flowed down the embankment to the intermittent unnamed tributary.

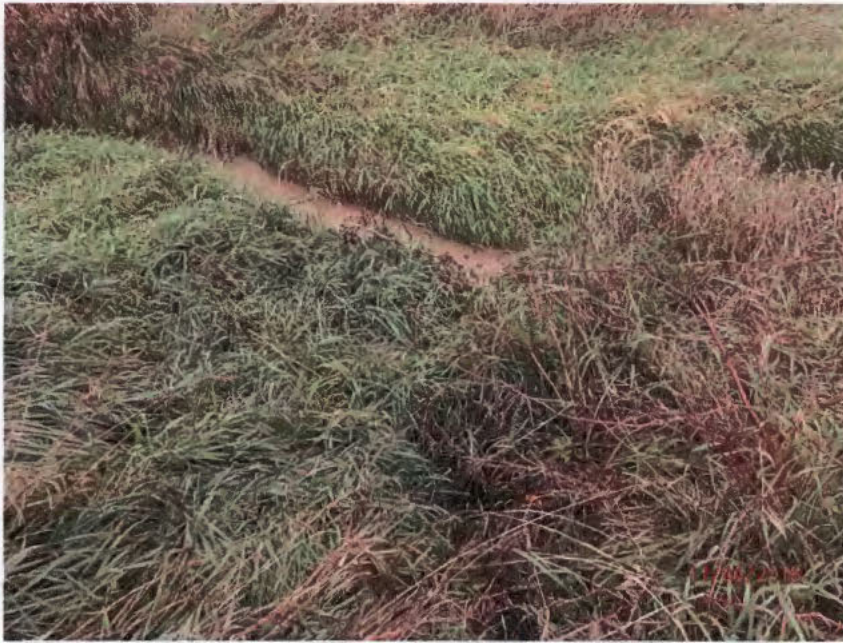
74: PB060076

Description: The intermittent unnamed tributary upstream of the confluence with the discharge pathway.
